Final
Preliminary Assessment/Site Inspection
Kalakaket Creek Radio Relay Station
Alaska

March 1995

United States Air Force 611th Civil Engineer Squadron

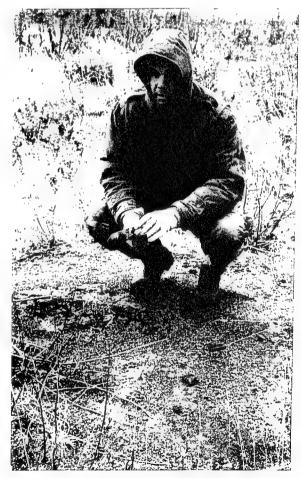
of the samples screened using the IR analyzer; concentrations range from 237 to 32,600 mg/kg. Several of the samples with elevated concentrations of TPH were collected from areas with noticeable soil staining; however, the sample collected at EQ-FS-06 had no noticeable odor or staining, yet contained the highest concentration of AH (922 mg/kg) and the fourth highest concentration of TPH (12,600 mg/kg). The only physical evidence of contamination at this location was a lack of vegetation.

Figure 4-5. Soil Staining at Sample Location EQ-FS-10, Equipment Building AOC

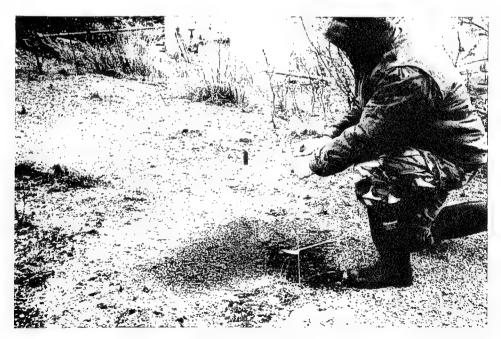
Figure 4-9. Sample Location DT-FS-03 is the Largest Area of Soil Staining at the Diesel Tanks and Fill Area AOC

NFRAP status is recommended for this AOC. Since the tanks have been drained and are empty, there is no threat of future release from the AOC.

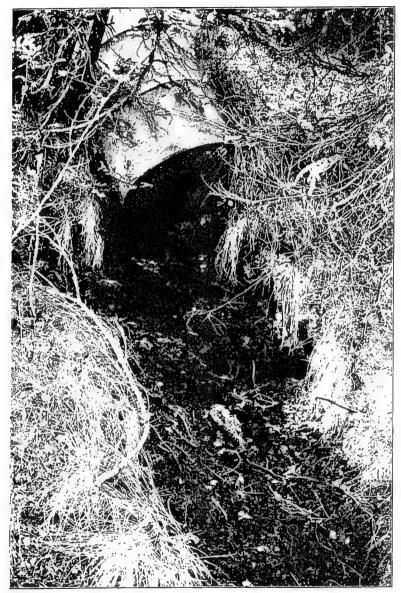
Remote Drum Cache—Empty and partially full drums were rolled down a hill into a ravine north of the station. Drums contained lube oil, mogas, antifreeze, combat gas, and roofing tar. Some drums have leaked and stained surface soils. Wastes potentially released consisted of lube oil, mogas, antifreeze, combat gas, and roofing tar. Contaminants of potential concern consisted of GRO, DRO, VOCs, SVOCs, PCBs, pesticides, and metals.

Figure 4-19. Soil Staining at the Remote Drum Cache

The drums should be removed from this AOC to restore the area and prevent further releases. Also, the stained soil should be excavated and removed, followed by confirmation sampling. Following the removal action, the drum cache should require no further action.
